Digital Cellular Modem-200 (DCM-200)

Description of Error and Status Codes

Document: 900337
Date: July, 2003
Revision: -

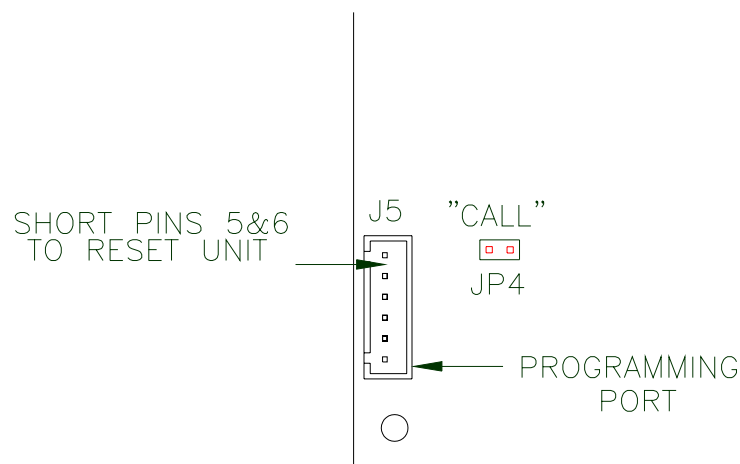
Figure 7-1
Location of Unit Reset Pins

If the unit needs to be reset manually, two pins on the "J5" programming port connector can be momentarily shorted together, as shown in Figure 7-1.

- Figure 1-1 Location of Unit Reset Pins
- Figure 1-2 LED Indicators
